<b>TSB #:</b>	TSB30032401	<b>Release Date:</b>	6/28/2024
<b>Main Group:</b>	00 - General Information (Recalls,Campaigns, Maintenance ..)		
<b>Subject:</b>	Cabin Electric Water Pump		
<b>Vehicle:</b>	FM29 OCEAN	<b>Production Range:</b>	MY 2023 and MY 2024 Fisker Ocean vehicles (11,308) are affected by this recall
<b>Model Year(s):</b>	2023 - 2024	<b>Region(s):</b>	USA/CANADA/EU
<b>Mobile Service:</b>	Choose an item.

**Recall:** **SA3014300002**

## Cabin Electric Water Pump Replacement

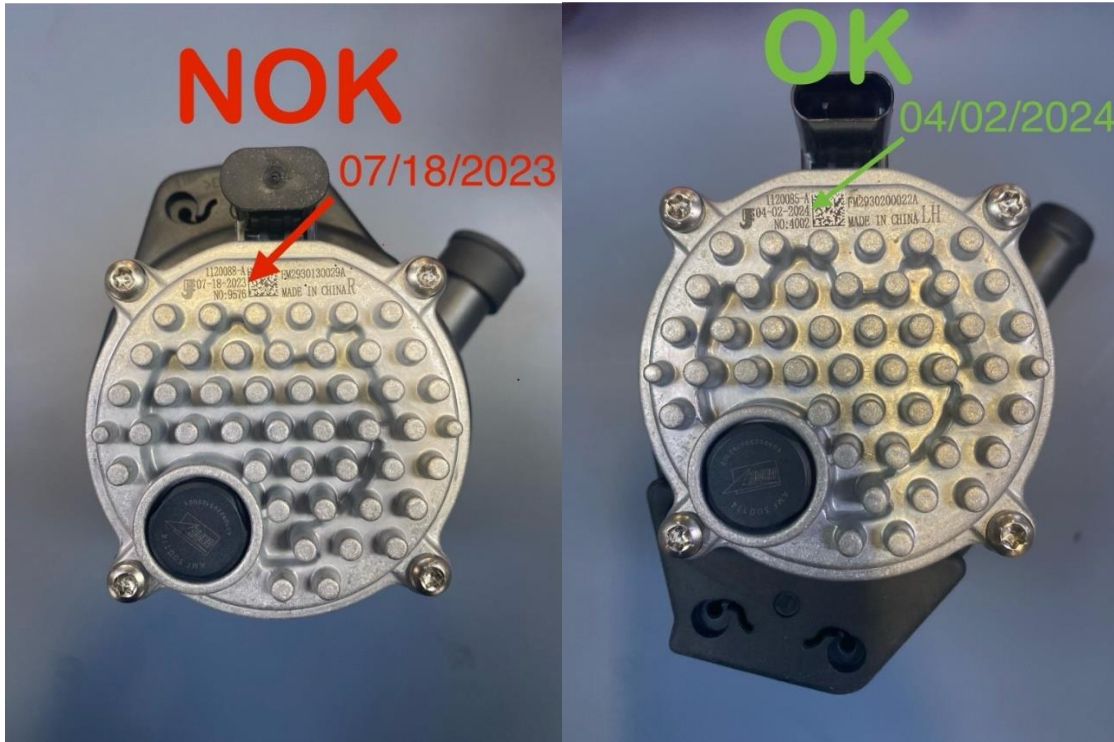
**Part Identification:** Replacement Water Pump is identified by a stamp date of **02/22/2024** or later “see pic below”.

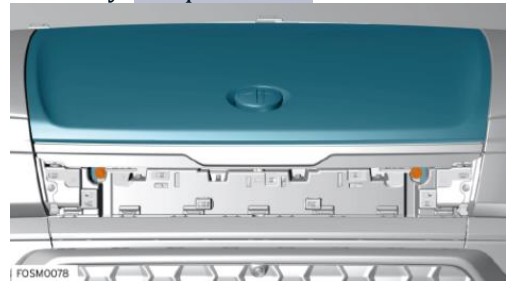
FOSM0078

3. Remove service lid & Remove M8x25 bolts (x2) securing hood to front bumper assembly. Torque 19 Nm.

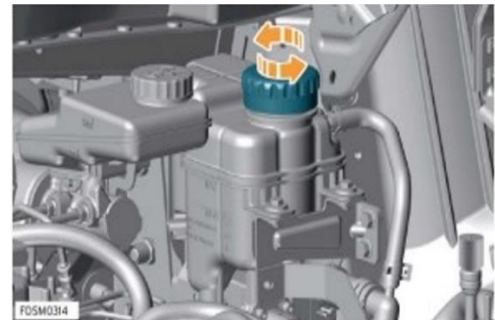
FOSM0314

5. Remove surge tank cap.

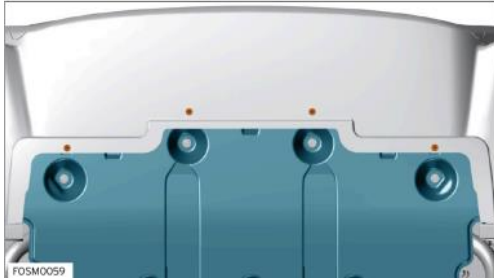
7. Remove M4x15 screws (x4) securing front underbody cover to front bumper assembly. Torque 2 Nm.

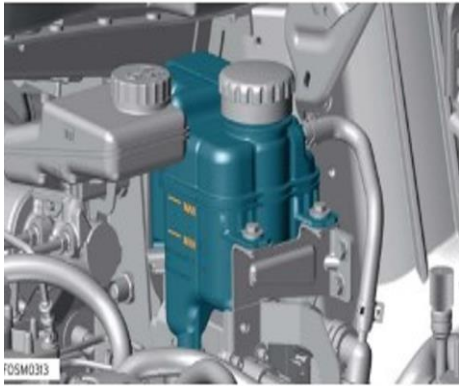
14. After replacing the water pump and reconnecting coolant hoses, visually check coolant level in surge tank. The Coolant level should be between MIN and MAX marks.
15. Fill surge tank to MAX level indicator with recommended coolant.
16. Operate water pump using Fisker Aftersales Service Tool (FAST). Allow pump to run for 5 minutes, this will circulate coolant throughout system to bleed out any air.
17. If required, top up surge tank to the MAX level.
18. Reinstall surge tank cap and wipe clean any spillages.
